SPX Corporation 5885 11th Street Rockford, IL 61109-3699 USA Tech. Services: (800) 477-8326 Fax: (800) 765-8326 Order Entry: (800) 541-1418 Fax: (800) 288-7031 Parts List for:

RH1505

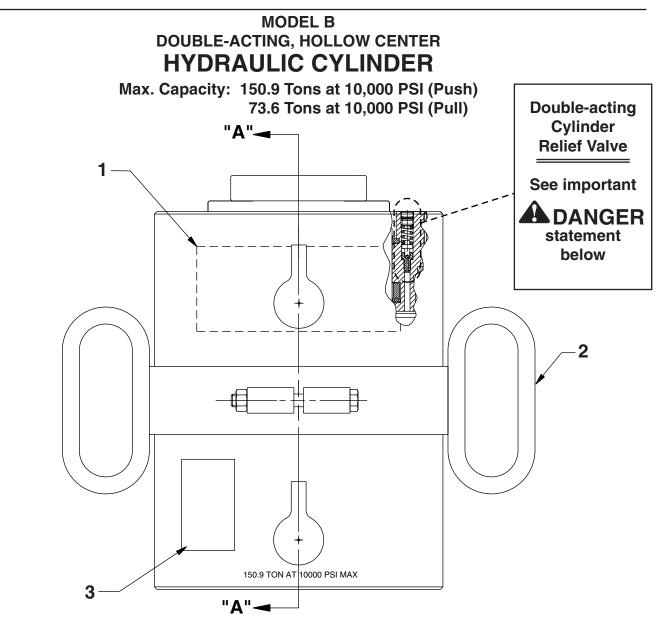
ltem No.		No. ReqÕ	d Description		
1 2	351859 59234OR9		Decal, Tradename (Power Team) Handle, Cylinder Lift Decal, Warning	Sheet No.	1 of 1
3	203908			Rev. 2	Date: 22 Mar. 1999

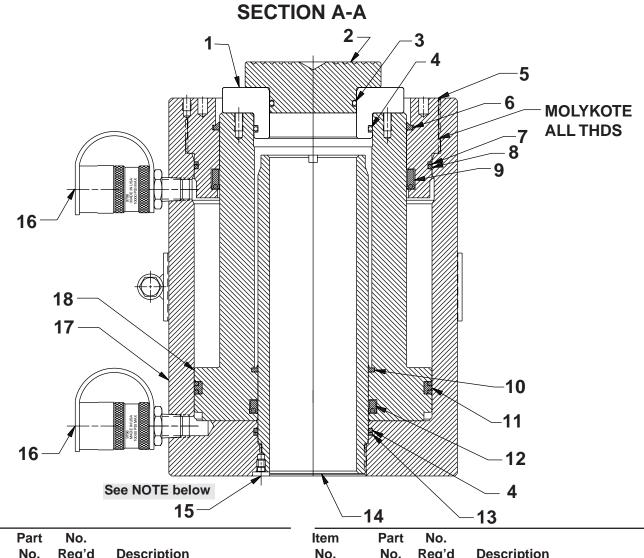
No.	No.	Req'd	Description	No.	No.	Req'd	Description
1	37287	1	Insert, Plain	11	*16313	1	T-seal (7.00 x 6.50 x .36 L)
2	37288	1	Insert, Serrated	12	*16316	1	U-cup (3.75 x 3.25 x .38 H)
3	*10295	1	O-ring (2.50 x 2.25 Nitrile)	13	*†19166	1	Washer, Backup (3.50 x 3.25)
4	*10297	2	O-ring (3.50 x 3.25 Nitrile)	14	36406	1	Pipe, Stand (Bottom out and back off
5	51043	1	Nut, Retainer (10-32)				1/8 revolution before adding set
6	*207593	1	Wiper, Rod (5.94 x 5.50 URE)				screw; Molykote all thds.)
7	*†19176	1	Washer, Backup (7.00 x 6.75)	15	10556	1	Screw, Set (1/4-20 x 1/4;
8	*16317	1	O-ring (7.00 x 6.75 Nitrile)				See NOTE below
9	*16315	1	U-cup (6.00 x 5.50 x .56 H)	16	9796	2	Coupler, Quick Cylinder Half
10			Wiper, Rod (3.63 x 3.25 URE)	17	65995	1	Body, Cylinder
-				18	51044	1	Piston

Part numbers marked with an asterisk (*) are contained in Repair Kit No. 300154. Part numbers marked with a dagger (†) are contained in Viton Seal Kit No. 300228.

NOTE: Cylinders built after 1-1-99 do not use this set screw to lock the standpipe and cylinder body together. Loctite 242 is used on last 2-3 standpipe threads only!
